EXXARO KUMBA GROOTGELUK COALMINE – SOUTH AFRICA

In 2005 the Kumba Resources (now called Exxaro) started with the application of ZINGA on their infrastructure (6500 m² in total). Originally they applied only one thin layer of ZINGA (because they had used too much solvent) which was not enough. After application of a new ZINGA layer in March 2006, the customer was very satisfied. There were inspections in October 2006 and again in February 2007.

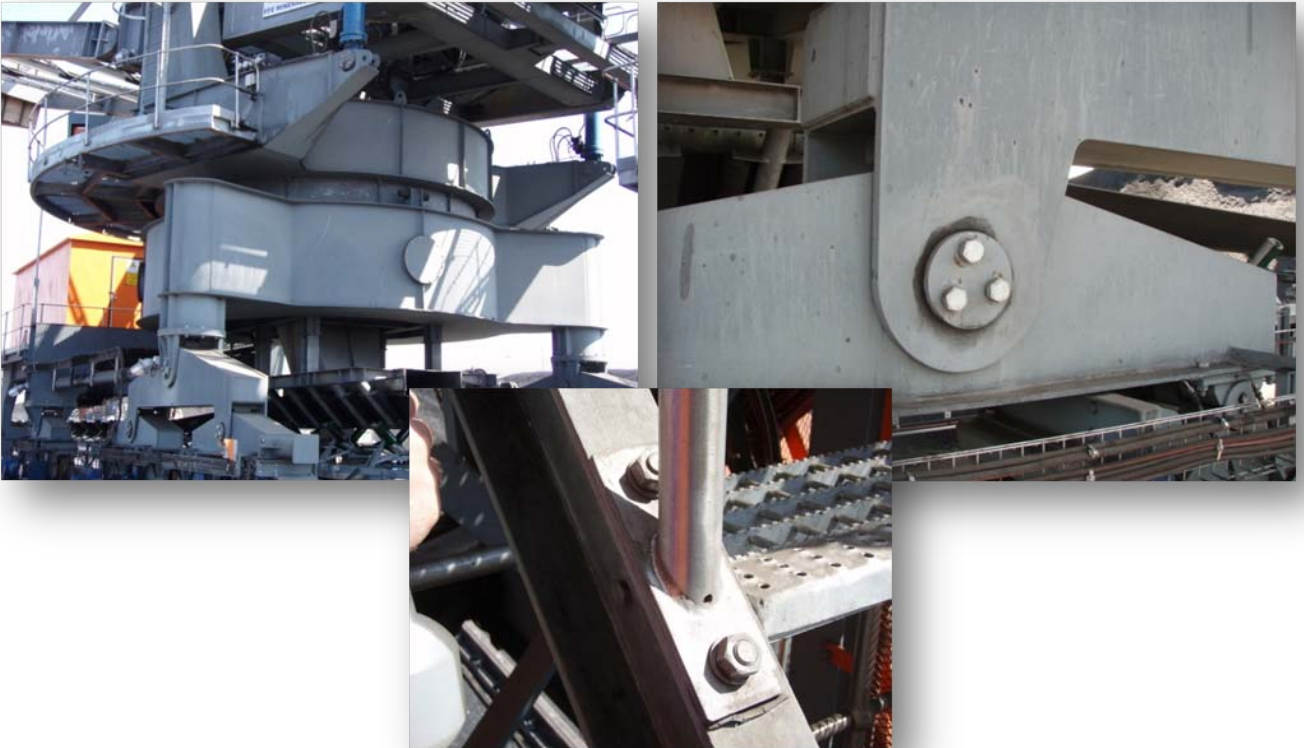
This is the conclusion of the inspection rapport dated 02/02/07, demonstrating the excellent behaviour of ZINGA.

- 1 As per the photographic report I conclude that Zinga has achieved galvanic protection and that no deterioration of the coating was witnessed.
- 2 Structural steel installed in Plant above screens exposed to continuous moisture and water has shown no reduction on dry film thicknesses.
- 3 Column bases done with Zinga metall exposed to water, coal fines and occasional impact has shown no reduction in dry film thicknesses.
- 4 No cracking of the sealing compound from the steel column to cement base was witnessed.
- 5 Zinga must be applied in accordance with MPCS 04 and it's the responsibility of the applicator to ensure that required DFT'S are obtained.

As the representative of Zinga Metall both O'Grady's and Zinga Metall Belgium believe that it is essential that a strict Quality Control plan is introduced to eliminate application faults.
